# AIR SERVICE INFORMATION CIRCULAR

## FIFTY-HOUR ENDURANCE RUN OF MODEL W-1 ENGINE

(FIRST EXPERIMENTAL MODEL)

Prepared by Engineering Division, Air Service  
McCook Field, Dayton, Ohio  
October 3, 1921

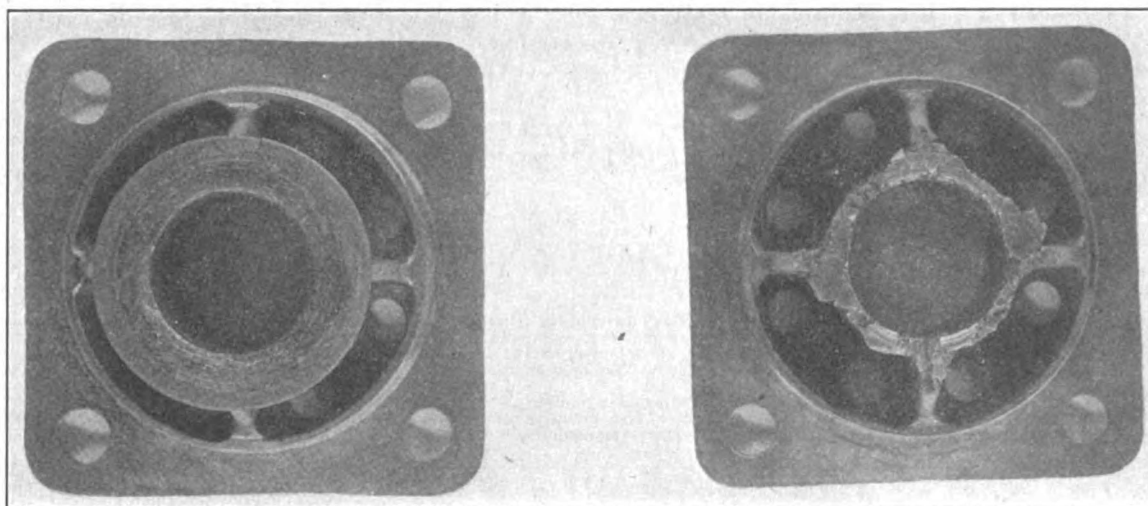
FIG. 7.—Camshaft drive-shaft lower bearings (upper) after preliminary runs on dynamometer.

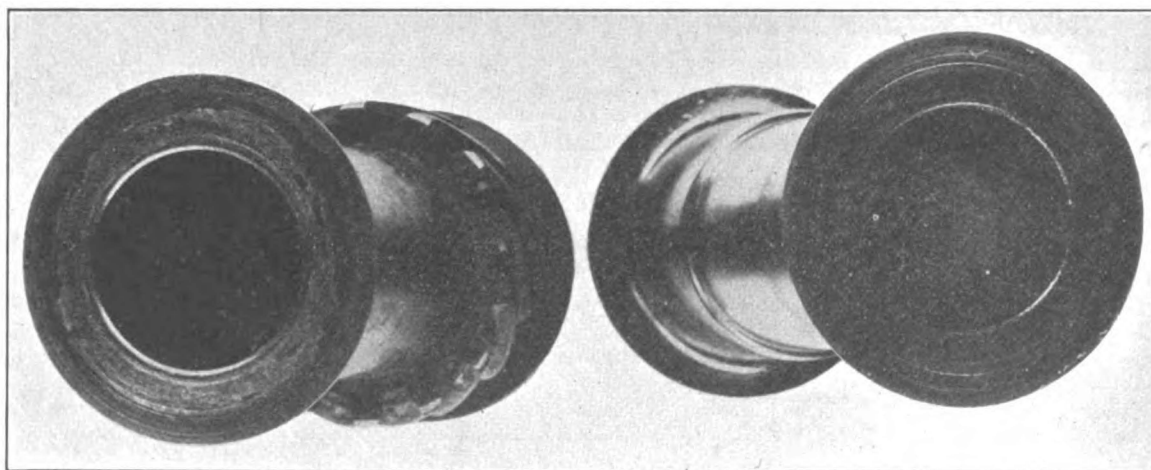
FIG. 8.—Lower center and lower side driveshaft spacing sleeves after preliminary runs on the dynamometer.

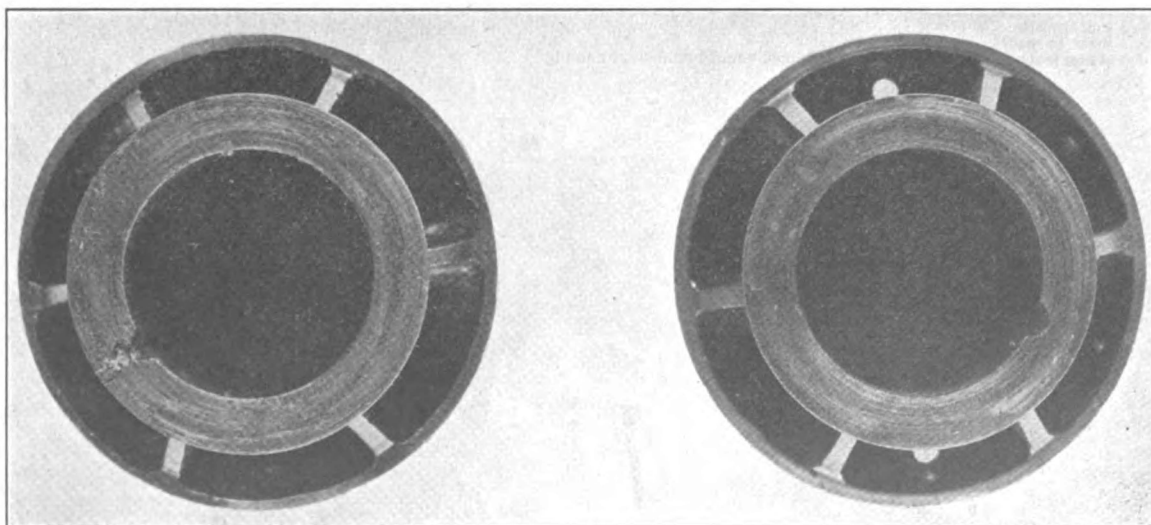
FIG. 9.—Camshaft drive-shaft bearings (lower) after preliminary runs on dynamometer.

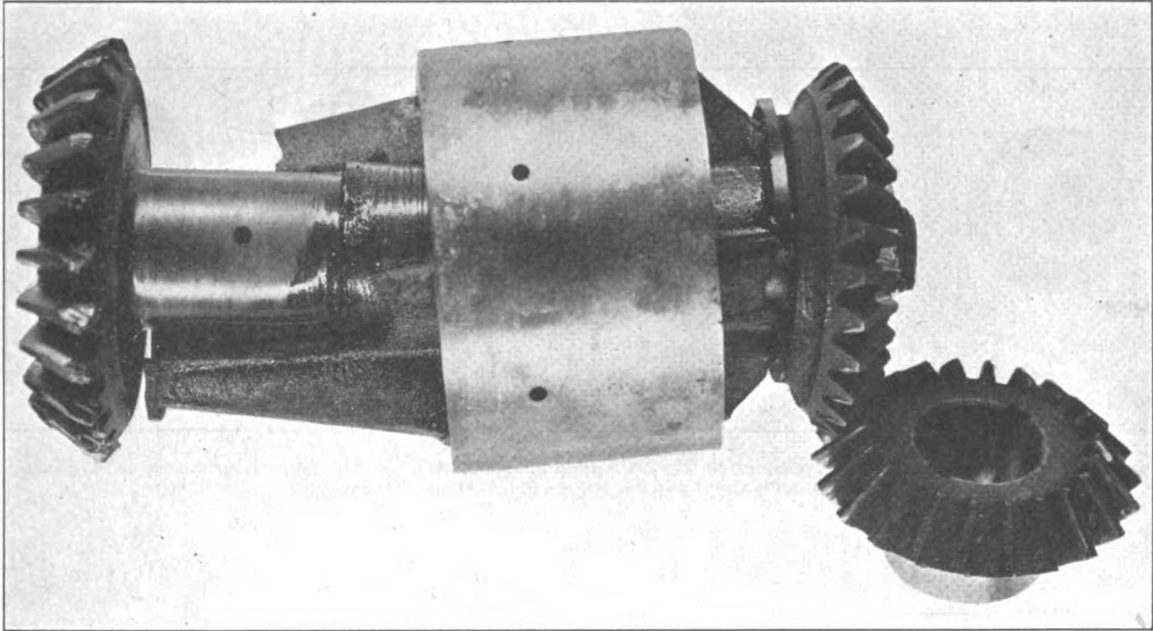
While making the preliminary runs on the dynamometer the bronze bearings, in which the water and oil pump drive shafts run, were burnt out (see fig. 10) due to lack of lubrication. The only lubrication supplied to them at that time was the overflow from the cam-shaft housing. When the bearings were replaced provision was made for supplying direct lubrication to these bearings and no further trouble was encountered throughout the test. In the improved design the bronze bearings will be replaced with ball bearings.

FIG. 10.—Burnt bearings oil and water pump gear assembly. This failure occurred during the preliminary runs on the dynamometer.

The cam shaft, water, and oil pump drive shaft bronze bearings will be replaced by ball bearings.

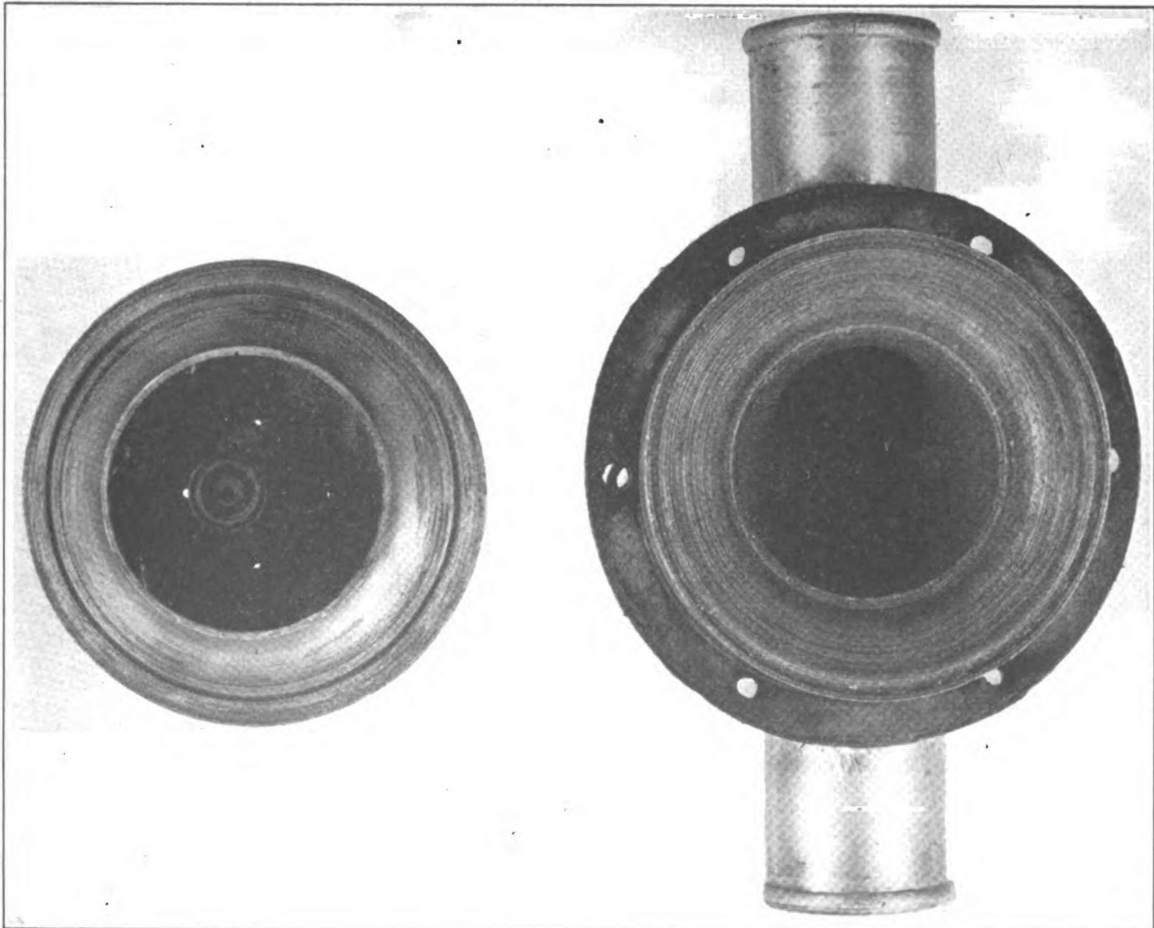
The lower case and impeller were badly worn by rubbing early in the test. The shaft was slightly rusted. (See fig. 11.)

FIG. 11.—Water pump showing wear on impeller and lower casing. The wear developed during the dynamometer runs, but the pump was used during the torque stand after lignum vitae was substituted for the bronze button on the case.

The assembly of the water manifold to the cylinders should be simplified. The water pump will be redesigned. The new design will have a shoulder on the impeller shaft supported by a bronze bushing to prevent the impeller scraping the pump case. There will be three outlets on the pump, one of which can handle the water discharge alone while the discharge can be taken care of by the other two when the first is blanked off. A drain plug of new design will be incorporated in the lower part of the pump making it possible to drain the cooling system by screwing off a spanner nut. This nut also provides a seat for a gasket held against the drain passages when screwed up tight.

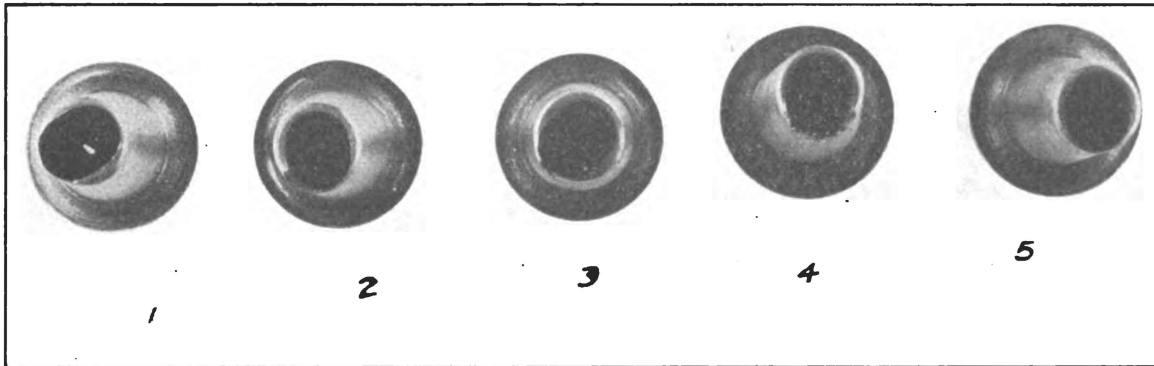
Excessive wear of valve guides occurred frequently during this test. In all 14 replacements were made. A

metallurgical analysis of the valve guides showed that they were made of material which was practically the same as has been successfully used with the Liberty engines. Wear is attributed to stress of service. None of the valve guides in the center bank were replaced. The weak crank case evidently allowed considerable weaving in the right and left banks. In the photographs (figs. 12 and 13) No. 1 had run only 3 hours. The other valve guides had been run for 35 hours.

FIG. 12.—Worn valve guides after 35 hours running. No. 1 in this figure was removed April 28, 1921, after running 2 hours and 15 minutes. This is also typical of the valve guides replaced as indicated on page 17.

An investigation should be made in an effort to secure better valve-guide material.

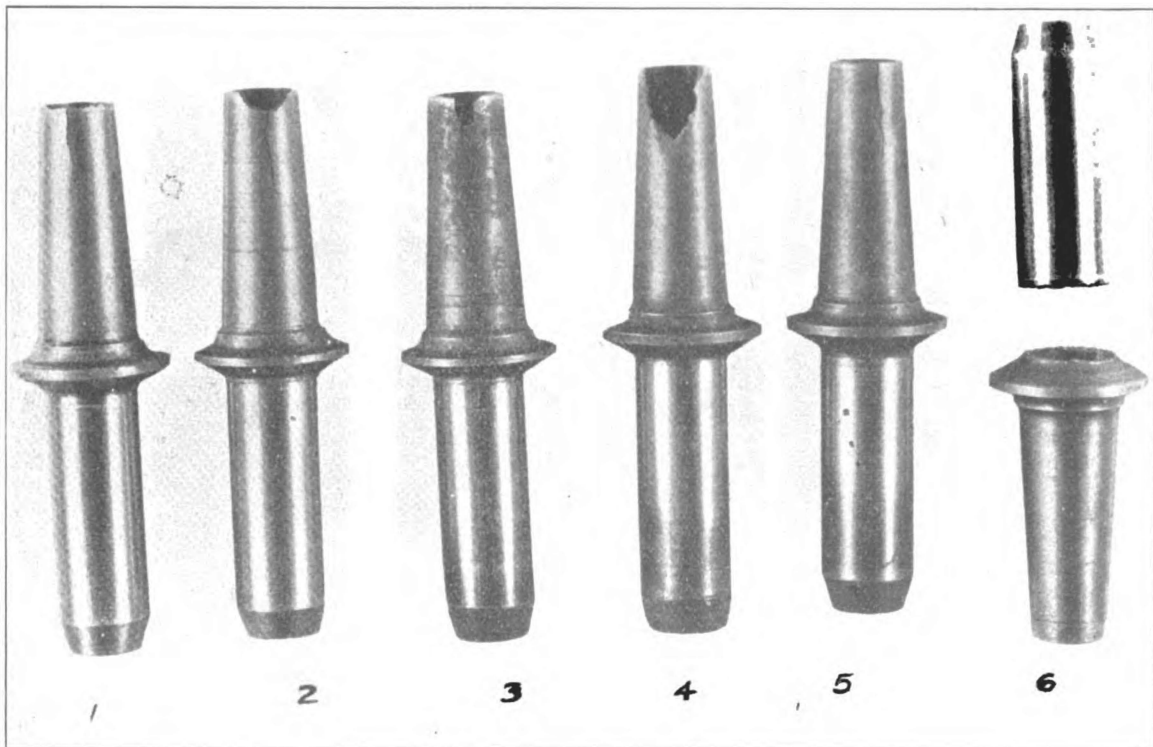
FIG. 13.—Worn valve guides after running 35 hours. No. 1 in this figure was removed April 28, 1921, after running 2 hours and 15 minutes. This is also typical of the valve guides replaced as indicated on page 17.

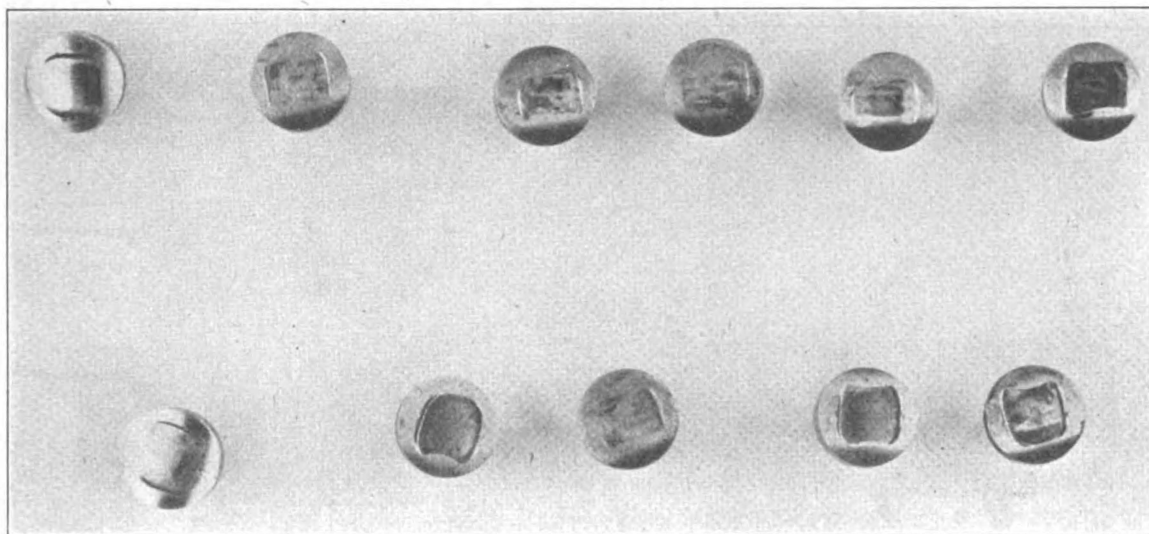
It was necessary to replace 13 inlet valve tappets during the run because of excessive wear. The excessive wear of the valve tappets can be attributed to the thin case obtained during the hardening process.

FIG. 14.—Worn valve tappets. These valve tappets were removed after running 38 hours.

The casehardening on the valve tappet should be deepened.

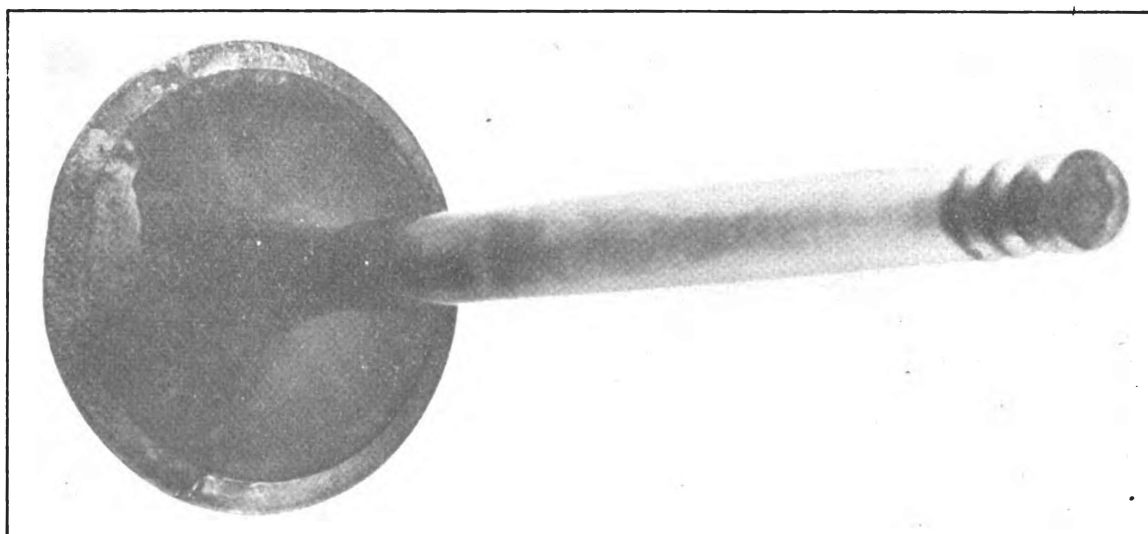
FIG. 15.—Burnt exhaust valve No. 6 L cylinder after running 38 hours.

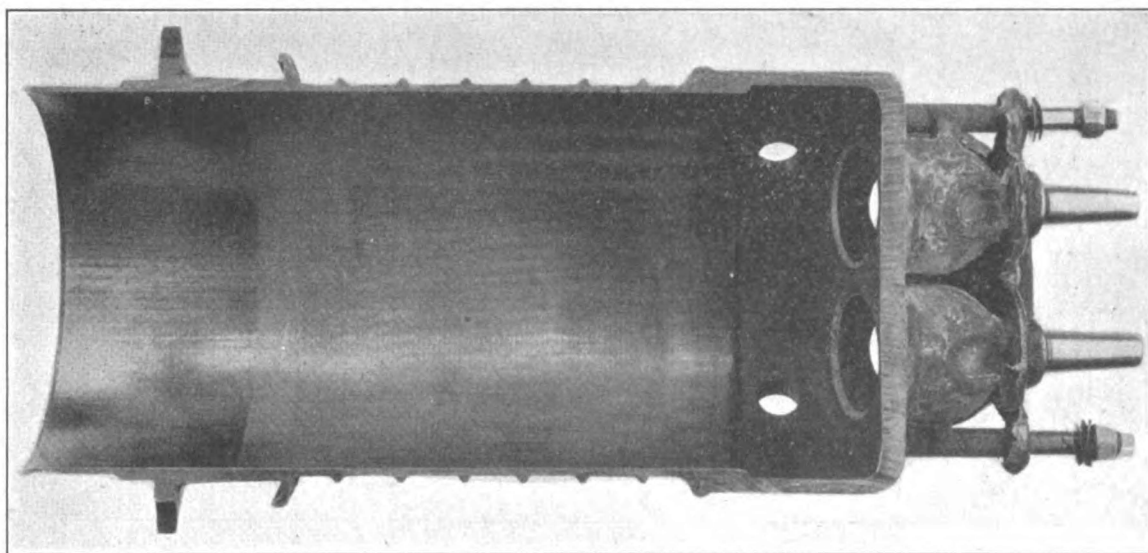
No. 15 stop.—Water leak at weld between cylinder head and barrel of No. 1C cylinder. (See fig. 16.) The cylinder was replaced with a new one. The front intake valve guide in No. 4R and both intake valve guides in No. 5R cylinders were badly worn and replaced. (See fig. 12.) The following outer valve springs were broken: No. 3R (front exhaust) 5L (rear intake), 6R (rear exhaust), 5R (both intake). Nos. 4R and 5R exhaust valves were burnt. They were replaced. One cylinder stud between 5R and 6R cylinders was broken.

FIG. 16.—Sectional view of cylinder. A water leak developed in this cylinder after 40 hours and 15 minutes running at the junction of the cylinder head and barrel. The crack in the cylinder weld is not shown in this figure.

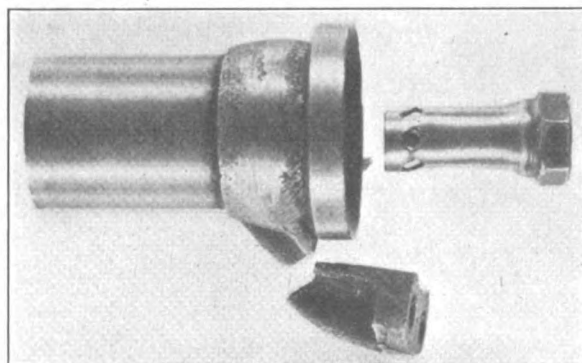
Another start was made, but after running 15 minutes a drop in speed of 150 revolutions per minute necessitated a stop. It was found that the small venturi tube bracket in the front left carburetor broke at a sharp fillet (see fig. 17) and distorted the main discharge nozzle.

FIG. 17.—Typical failure of small venturi bracket and main discharge nozzle of front left carburetor. As indicated in the log of run two failures occurred during ninth five hour period.

The carburetors should have single venturi equipment.

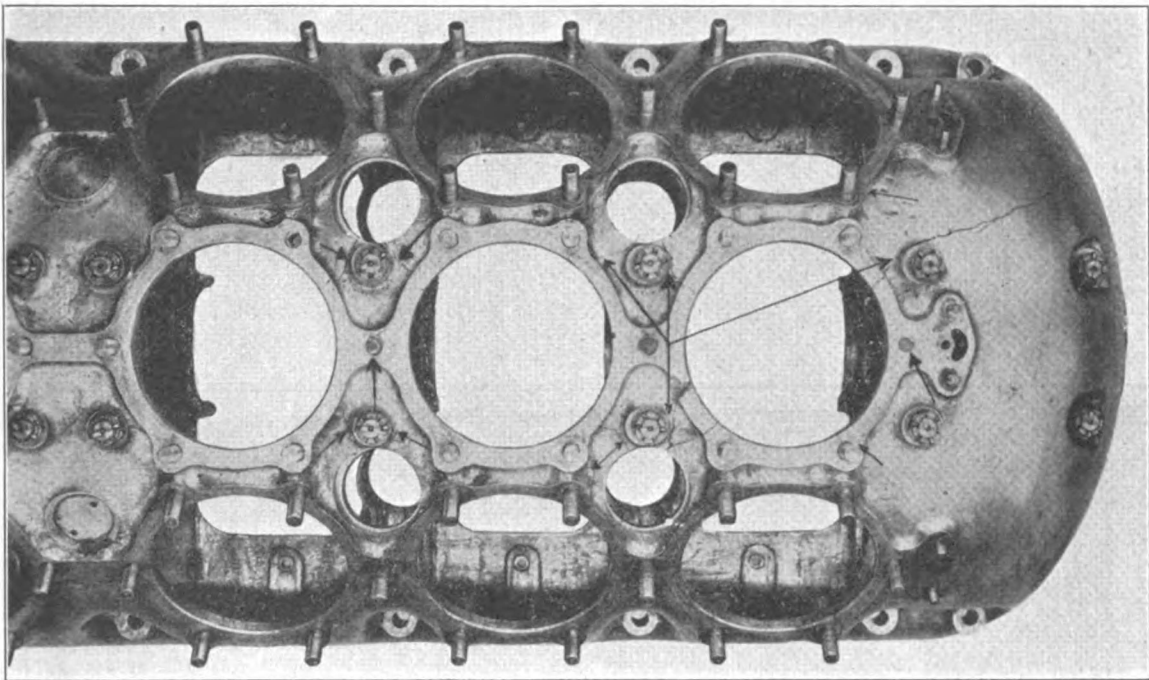
FIG. 18

The final failure of the crank case of the first design (see fig. 18), which was inherently weak, caused the test to be discontinued after running 44 hours and 45 minutes.

After running 45 hours and 45 minutes the engine began to weave badly and was stopped. The crank case was found to be so badly cracked that the test was discontinued. (See figs. 18 and 19.)

The upper crank case was badly cracked in front and under the first three cylinders in each bank. The cracks were interconnecting between the flanges and extended vertically in the webs at the induction-pipe opening. The hollow box web under the center main bearing was cracked and had a depression and thin section on the gear side of the web due to poor casting. The case was chafed at the parting flange. One cylinder to crank-case stud between 4C and 5C and one at the front of 6C were broken. (See fig. 18.)

Note fractures.

The new design which is now being made by the Engineering Division will afford greater strength to this part. A heavier web will be made at that portion of the crank case which accommodates the induction pipes. The web will continue straight back to the wall instead of following the contour of the induction-pipe hole. The opening in the webs which were made to reduce the weight will be made smaller and the webs will be beaded to give greater stiffness.

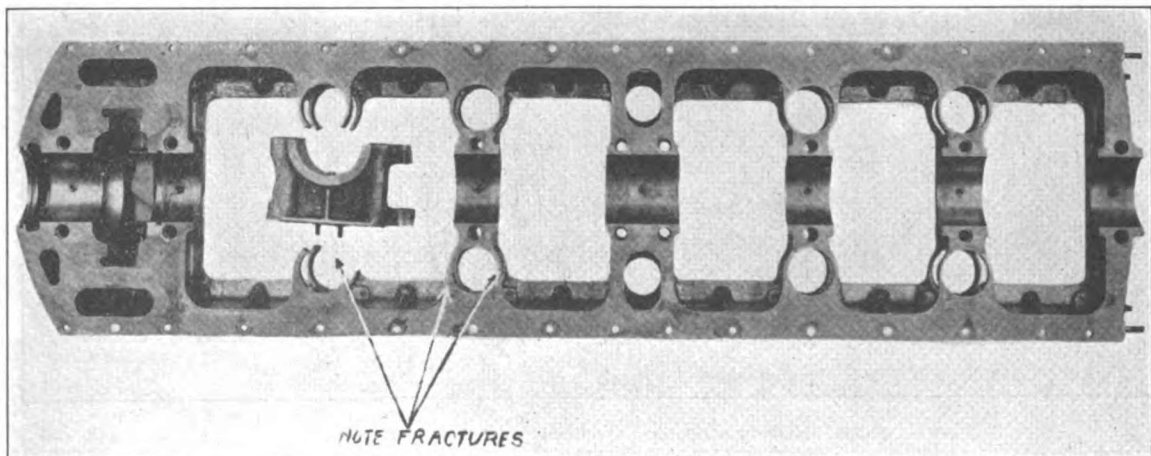
The webs under cylinders Nos. 4 and 5 and between Nos. 5 and 6 cylinders were cracked all the way through. The case was chafed at the parting flange. The bearing backing was chafed. (See fig. 19.)

FIG. 19.—Lower crankcase after endurance run showing fractures.

Strengthening of the webs similar to that in the upper crank case will also be done in the lower crank case.

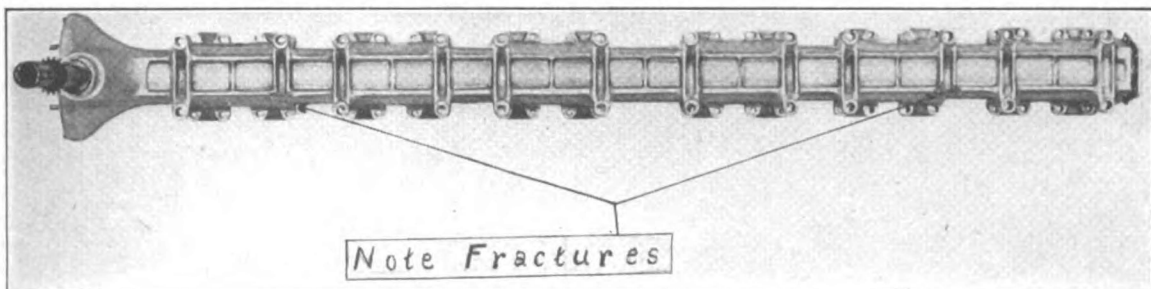
The cam-shaft housing was porous at 1, 3, 4, and 5 cylinders. The surfaces on the housing under rocker covers Nos. 3 and 4 were chafed. The rocker bearings showed the usual wear. The housing feet were broken at Nos. 1 and 5 cylinders. (See fig. 20.)

FIG. 20.—Camshaft housing showing typical fractures after endurance run. (Left bank.)

The cam-shaft covers should be stiffened. The cam-shaft housing should be stiffened by means of additional ribbing.

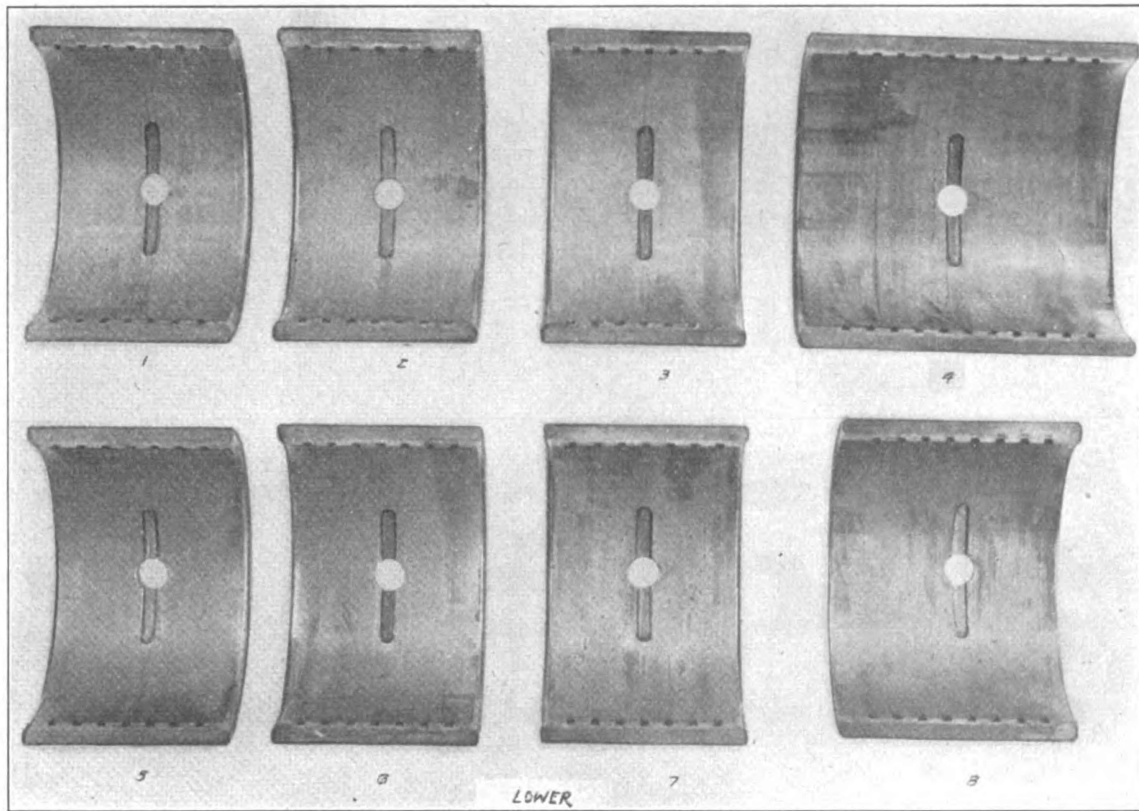
All bearings were slightly scratched. Lower bearings numbers 2, 4, 5, 6, 7, and 8 showed uneven wear and the backs of the shells were chafed. In general, the bearings were in excellent condition. (See figs. 21 and 22.)

FIG. 21.—Lower main bearings. Condition after endurance run.

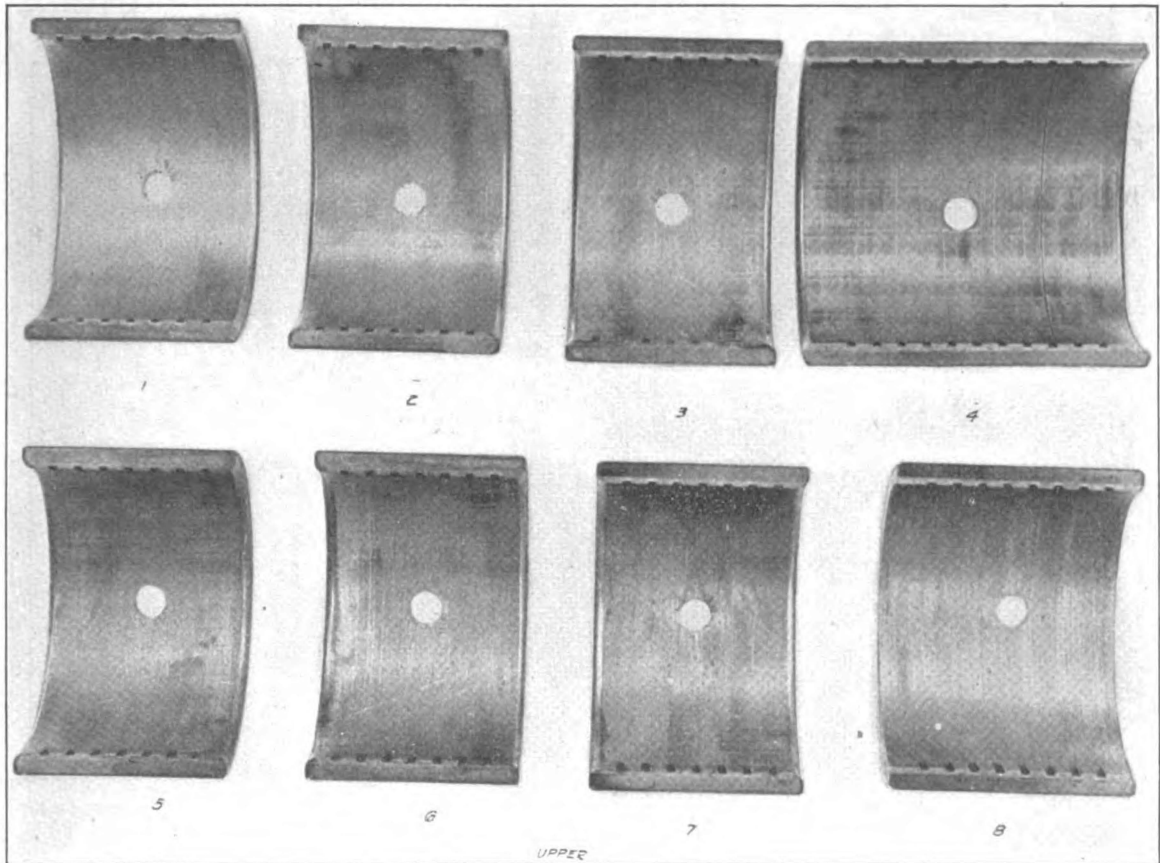
FIG. 22.—Upper main bearings. Condition after endurance run.

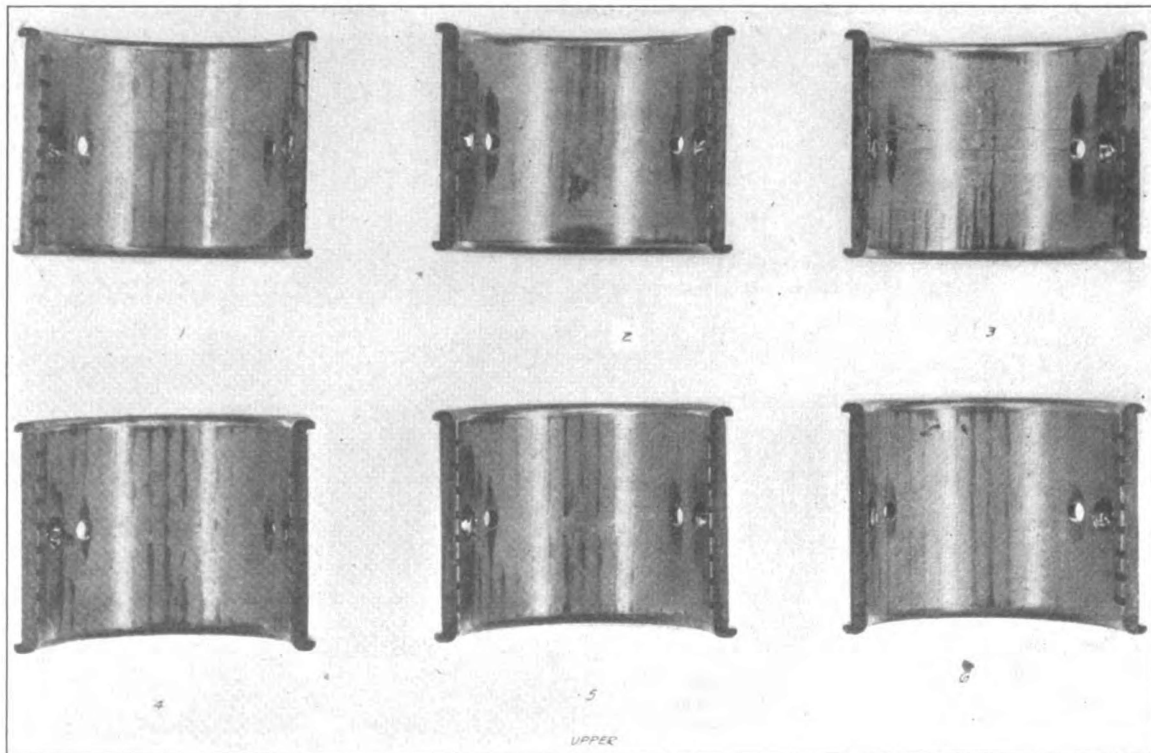
All the connecting-rod bearings were in excellent condition. (See figs. 23 and 24.)

FIG. 23.—Upper connecting rod bearings after endurance run. Note original reamer marks made during assembly of engine.

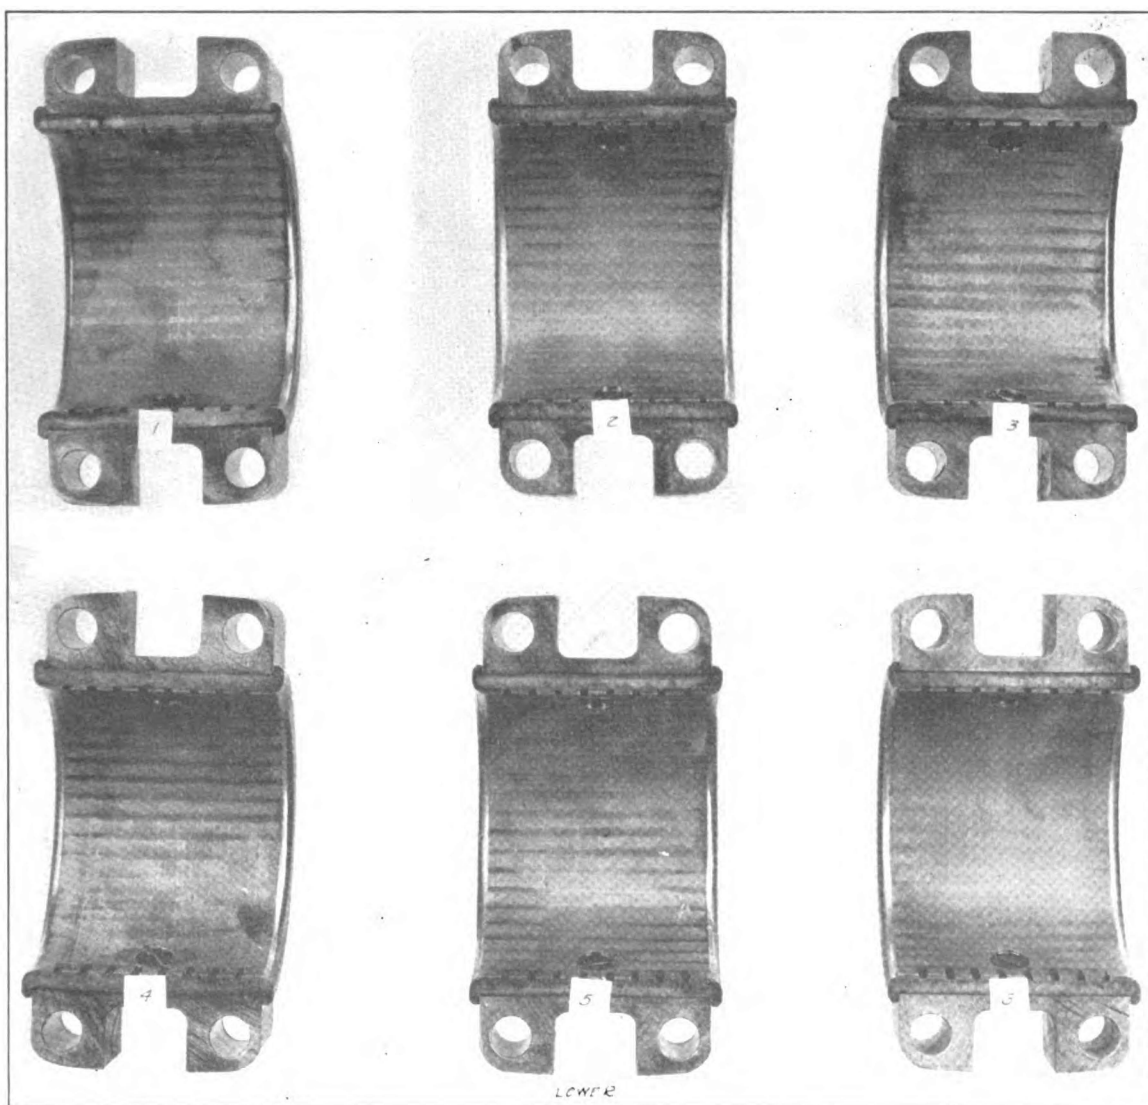
FIG. 24.—Lower connecting rod bearings after endurance run. Note original reamer marks made during assembly of engine.

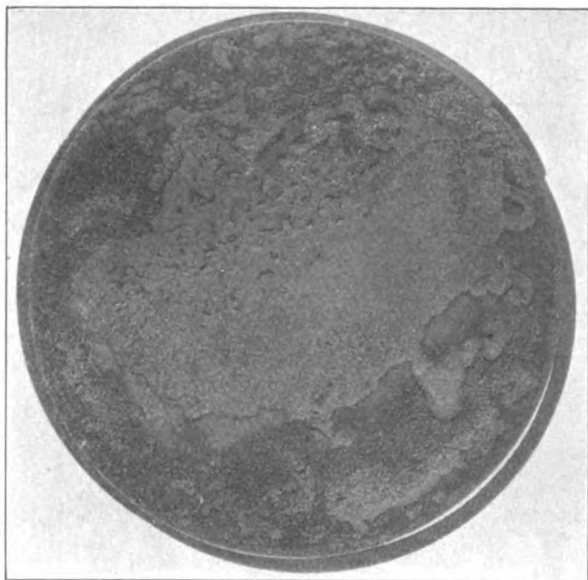
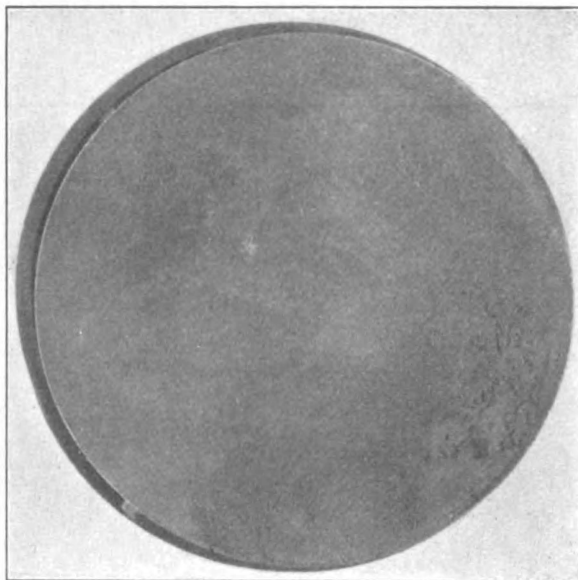
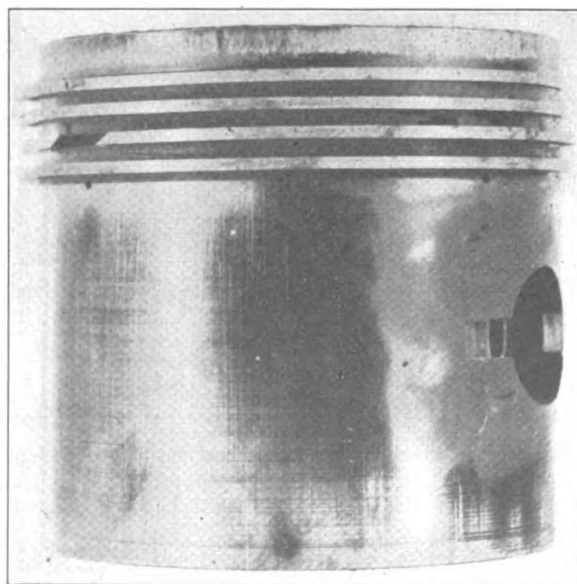
Numbers 1R, 2R, 3R, 4R, and 5R pistons had a fairly heavy carbon deposit on the piston head. There was no deposit inside the pistons underneath the head. All the pistons showed wear on the top land. The rings were all free in their grooves. The pistons showed no signs of erosion. The piston skirts were all oil burnt on the anti-thrust side. There were no "blow-bys." There was no appreciable wear in the piston bosses. (See figs. 25, 26, and 27.)

FIG. 25.—Typical piston showing heavy carbon deposit.

FIG. 26.—Typical piston showing average carbon deposit.

FIG. 27.—Typical piston showing wear on top land.

Provision should be made for better oil drainage by enlarging the oil return holes and recessing under the lower ring.

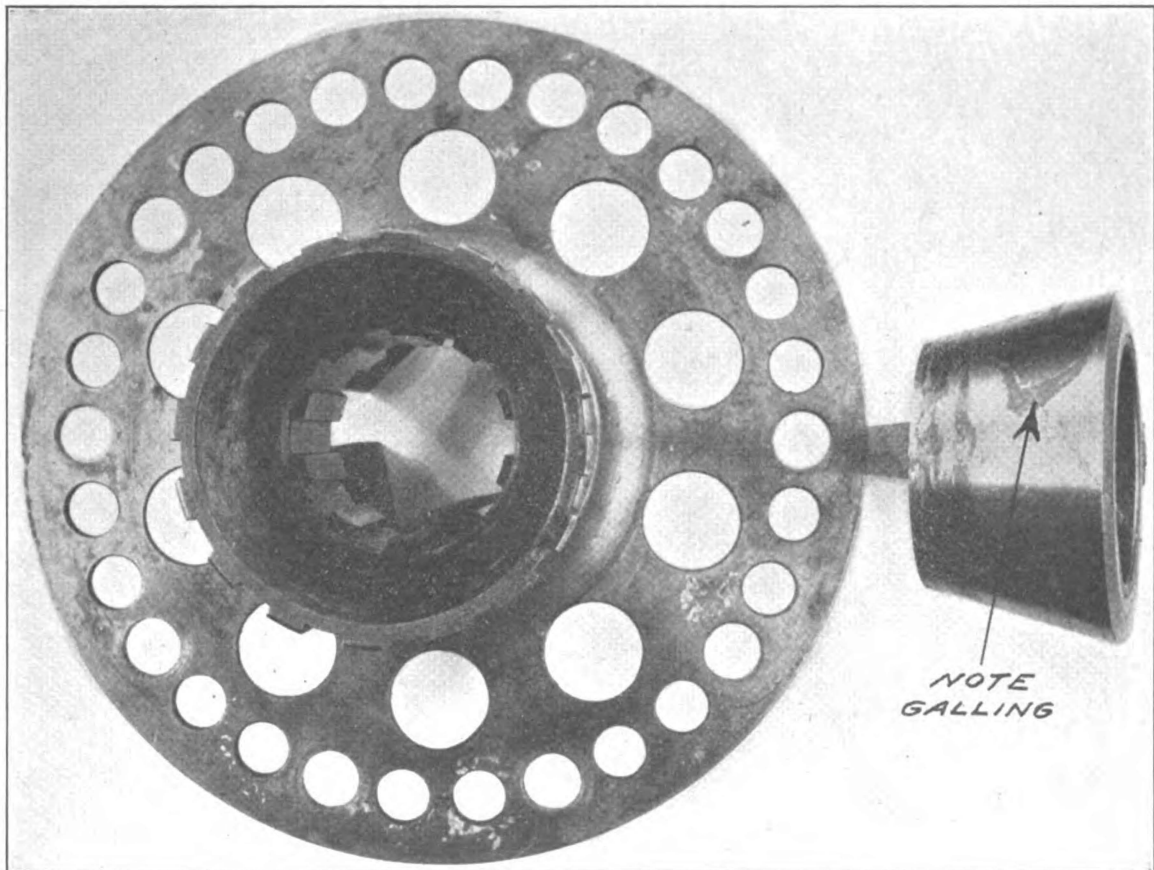
FIG. 28.—Propeller hub after endurance run.

The pitch of the front cone should be made steeper.
